The Fire Resistance  
Performance Of A Non-  
Loadbearing, Partition Wall  
Assembly Tested In  
Accordance With BS 476:  
Part 22: 1987, Clause 5

188642/A

18<sup>th</sup> February 2010

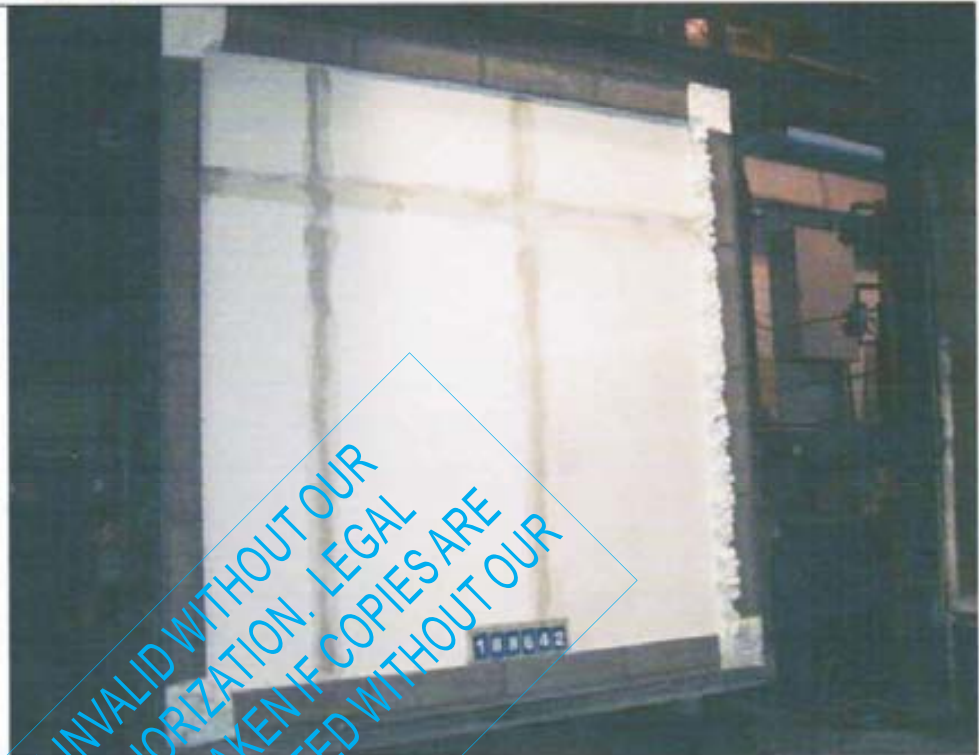
The exposed face of the test construction prior to testing

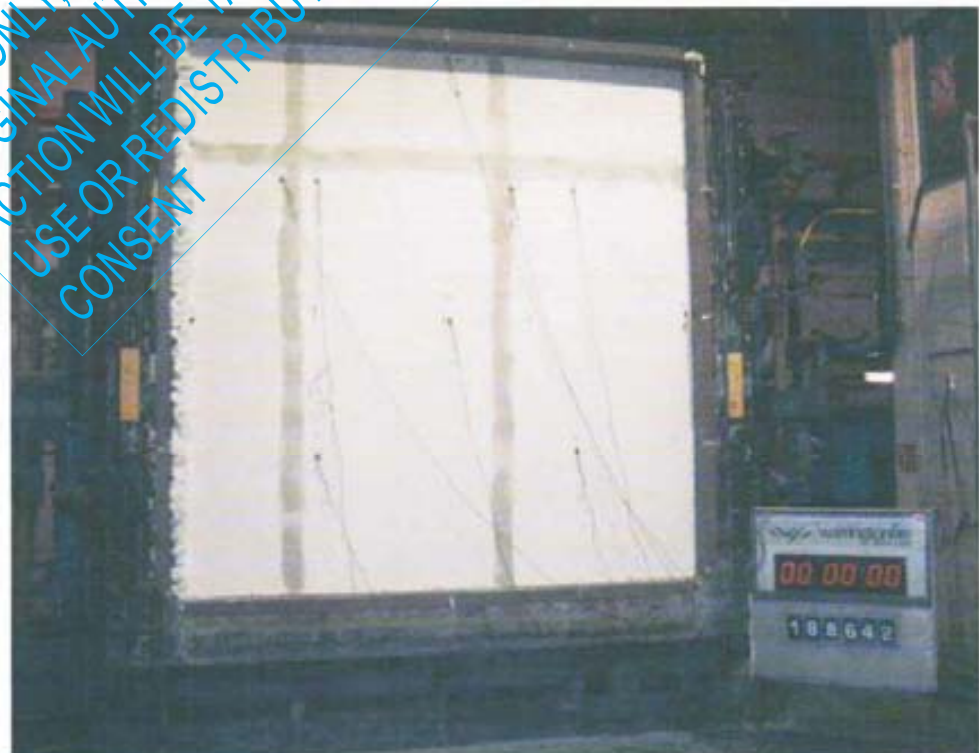
The unexposed face of the test construction prior to testing

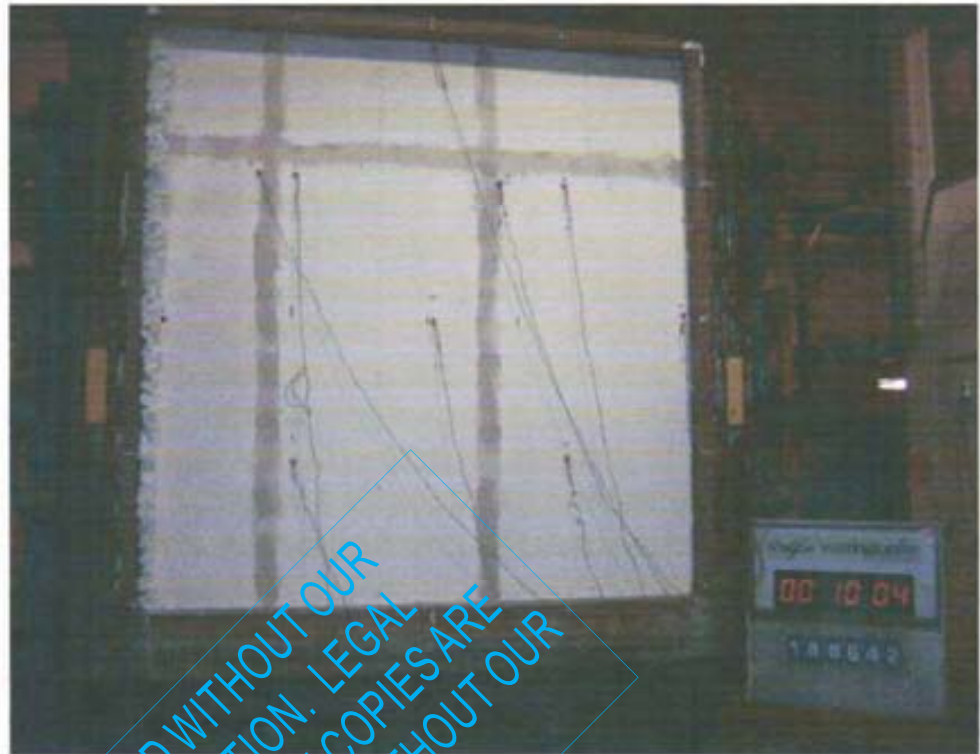
The unexposed  
face of the test  
construction after  
a test duration of  
10 minutes

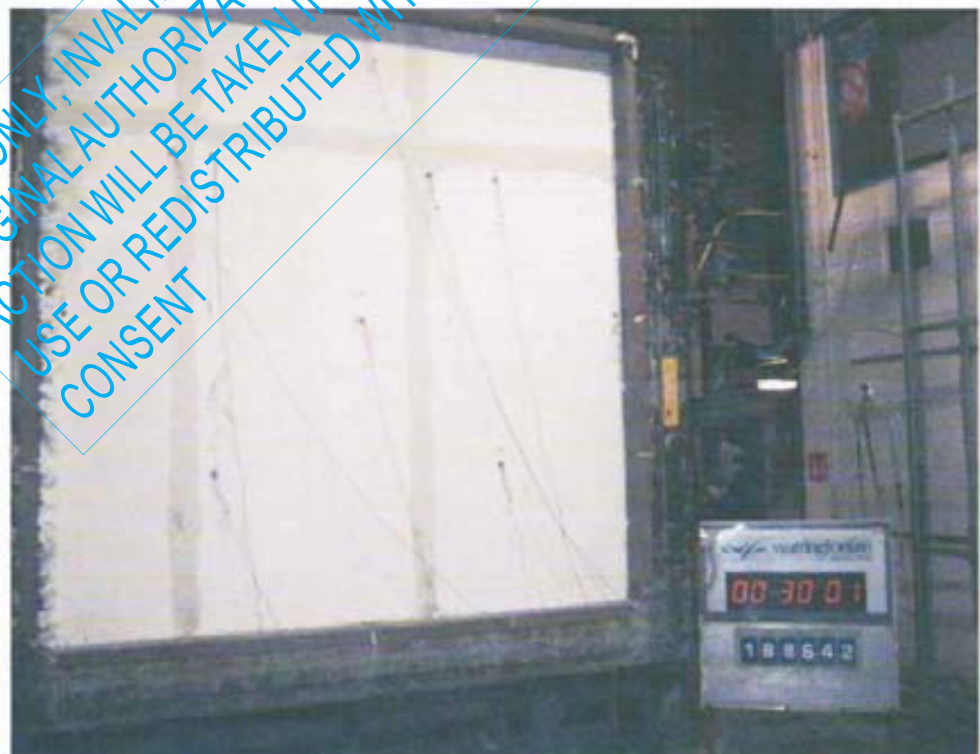
The unexposed  
face of the test  
construction after  
a test duration of  
30 minutes

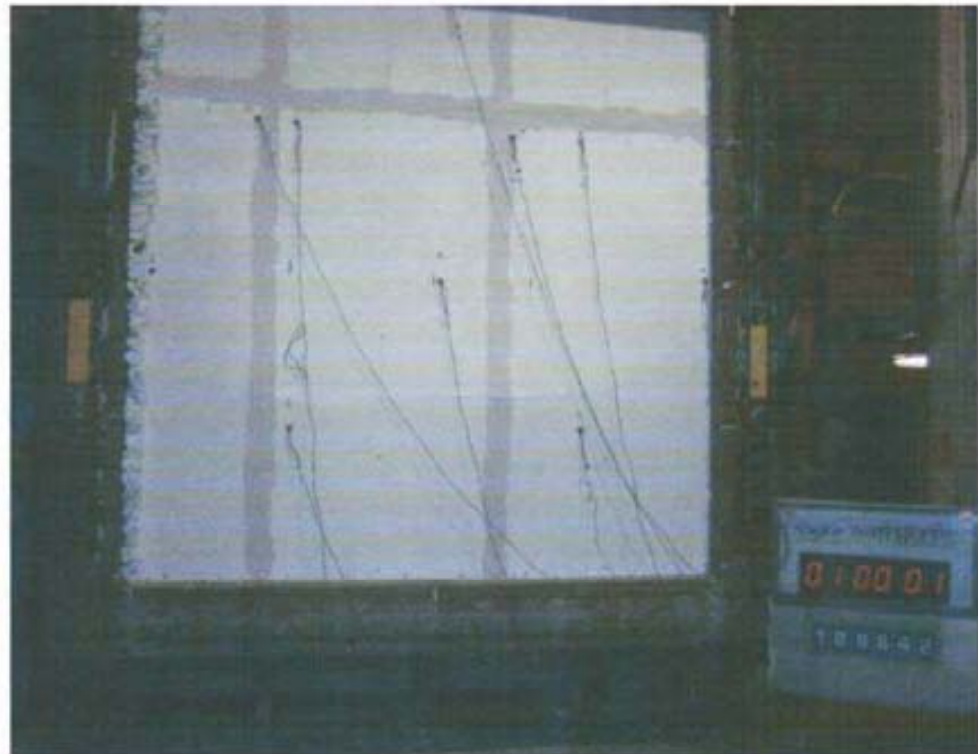
The unexposed face of the test construction after a test duration of 60 minutes

Time		All observations are from the unexposed face unless noted otherwise.
mins	secs	
		The ambient air temperature in the vicinity of the test construction was 11°C at the start of the test with no variation during the test.
00	00	The test commences.
17	00	Slight smoke release seen along the free edge.
19	30	The exposed face of the partition glows orange.
21	00	The centre of the partition starts to bow in towards the furnace.
30	00	The specimen continues to satisfy the test criteria.
41	42	A small hairline crack is visible on the unexposed face above thermocouple 6 caused by deflection of the partition, no smoke release is visible from the crack.
44	40	The exposed face now glows bright orange.
46	19	The unexposed face board also cracks just above thermocouple 5. Slight greenish discolouration is visible just above the top horizontal joint.
51	01	A horizontal crack is now visible running across the face of the partition just above thermocouples 5 and 6, no smoke release is visible from the crack.

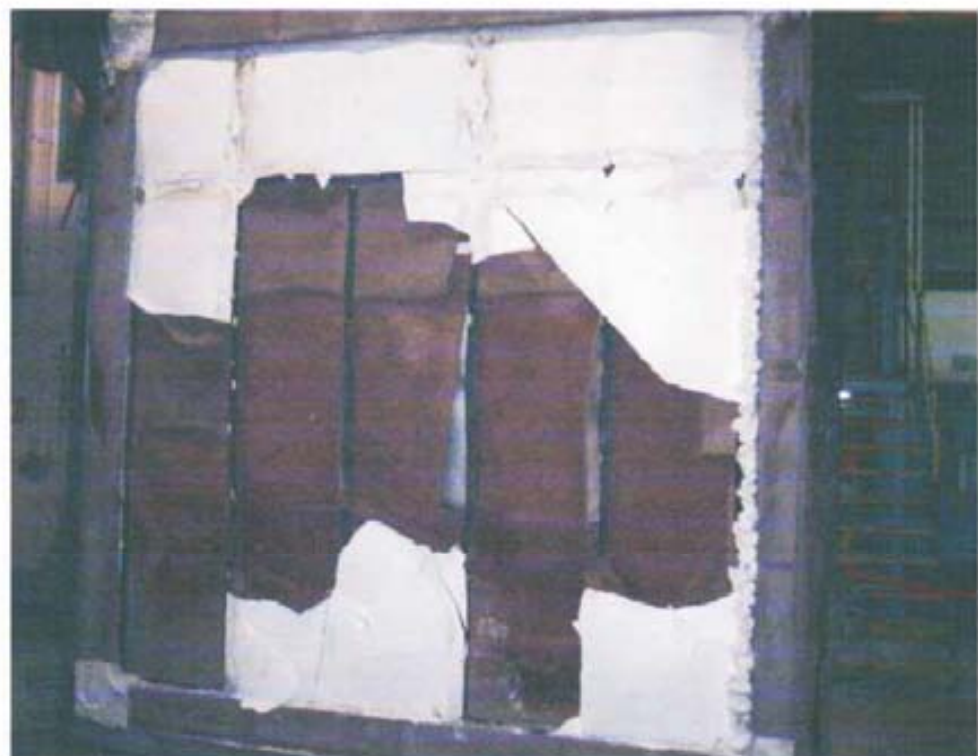
The exposed face of the test construction immediately after the test

60	00	The specimen continues to satisfy the test criteria.
62	00	Slight smoke release now visible from the horizontal crack just above thermocouple 6.
65	30	Very faint glowing can be seen near the stud behind the crack above thermocouple 6.
67	59	The horizontal crack continues to expand glowing can now be seen at approximately mid-span behind the crack.
70	18	At approximately mid-span it's now visible that the board and core behind the crack on the unexposed has fallen away.
71	30	A 6 mm gap gauge is able to penetrate into the furnace chamber at mid-span along the horizontal crack, over a distance greater than 150 mm. Integrity failure is deemed to have occurred.

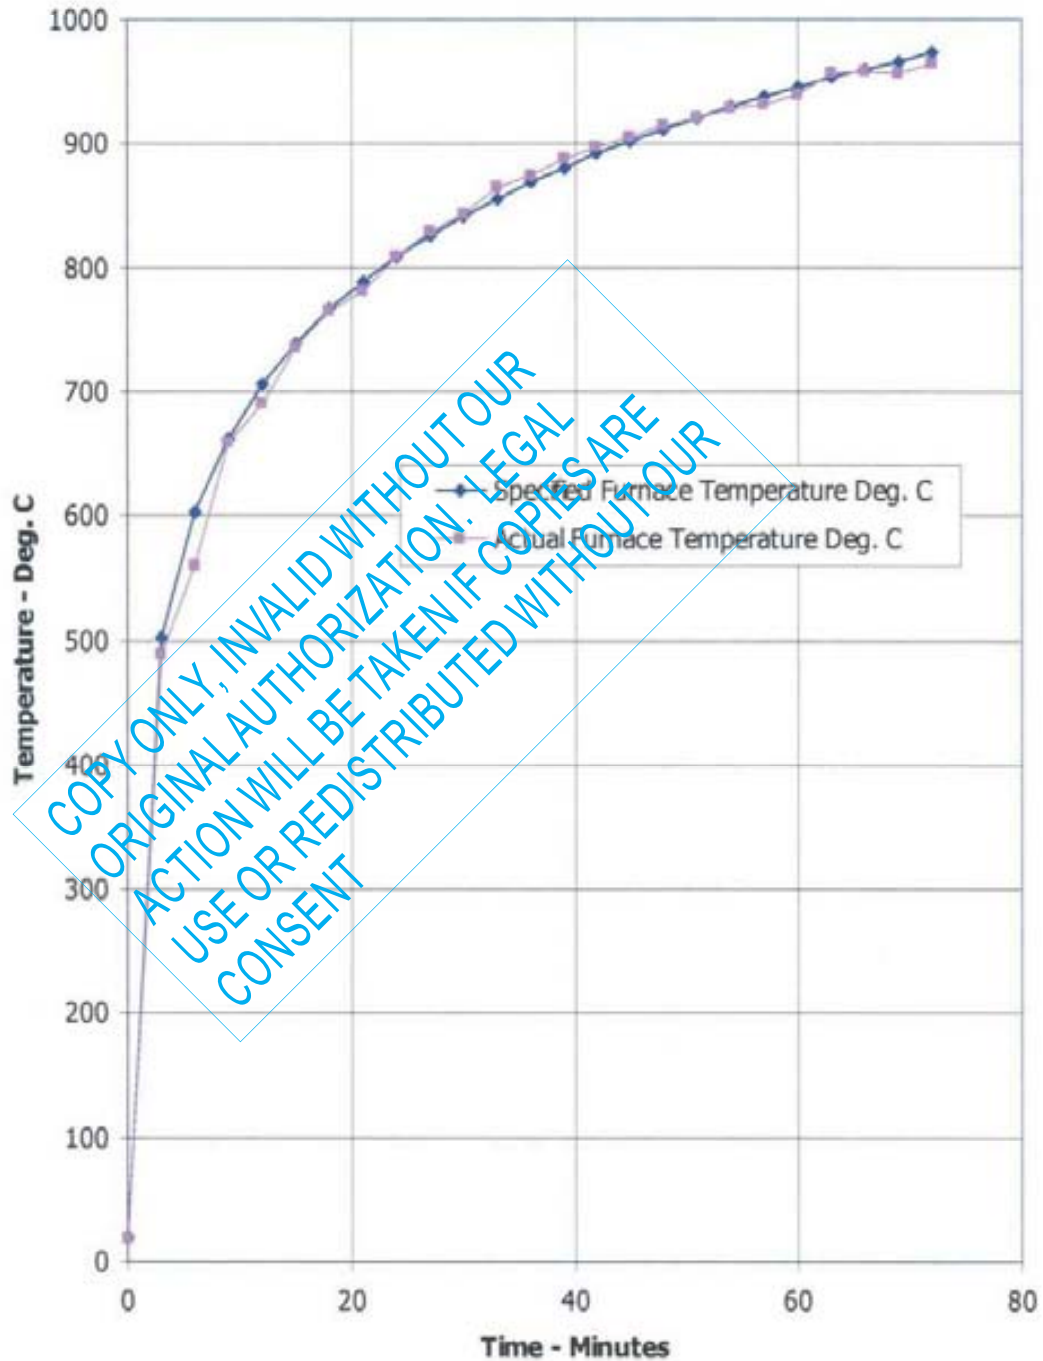
Graph showing mean furnace temperature, together with the temperature/time relationship specified in the Standard

Mean furnace temperature, together with the temperature/time relationship specified in the Standard

Time Mins	Specified Furnace Temperature Deg. C	Actual Furnace Temperature Deg. C
0	20	18
3	502	488
6	603	560
9	663	659
12	706	690
15	739	735
18	766	765
21	789	780
24	809	808
27	826	829
30	842	843
33	856	865
36	869	874
39	881	888
42	892	898
45	902	905
48	912	914
51	921	921
54	930	928
57	938	931
60	945	940
63	953	957
66	960	958
69	966	957
72	973	965

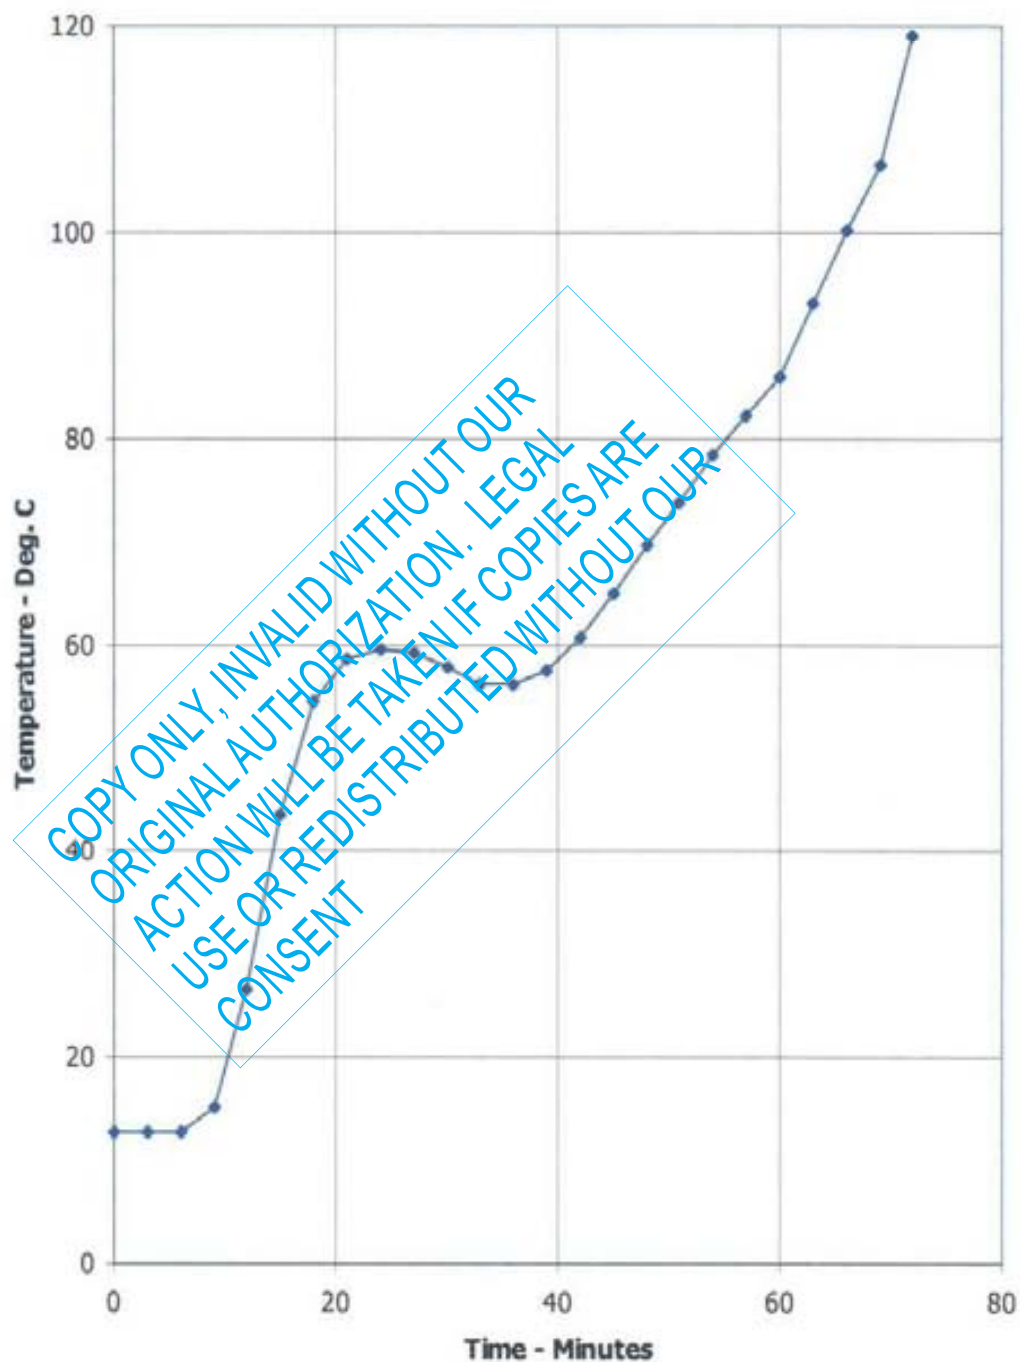
Graph showing mean temperatures recorded on the unexposed surface

Individual and mean temperatures recorded on the unexposed surface

Time Mins	T/C Number 2 Deg. C	T/C Number 3 Deg. C	T/C Number 4 Deg. C	T/C Number 5 Deg. C	T/C Number 6 Deg. C	Mean Temp. Deg. C
0	13	13	13	12	13	13
3	13	13	13	12	13	13
6	13	13	13	12	13	13
9	14	17	17	14	14	15
12	23	33	35	20	22	27
15	45	48	55	31	39	44
18	62	56	61	42	51	54
21	64	61	63	49	56	59
24	64	62	62	52	58	60
27	63	61	61	51	58	59
30	61	60	59	53	56	58
33	59	58	59	52	53	56
36	58	59	59	53	52	56
39	58	61	60	55	53	57
42	60	64	62	59	58	61
45	63	68	66	64	64	65
48	67	72	70	69	70	70
51	71	75	74	73	76	74
54	75	78	78	78	82	78
57	78	82	82	82	87	82
60	81	85	87	87	90	86
63	85	89	103	97	91	93
66	89	97	108	103	104	100
69	94	99	124	107	109	107
72	98	100	158	123	118	119
